HISTORIC MASONRY REPAIR & RESTORATION

Casey Weisdock, MSc

SEPTEMBER 19, 2022

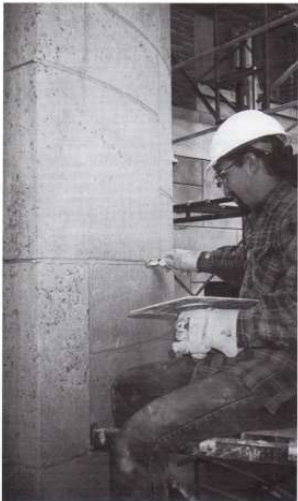
Figure 1. After removing deteriorated mortar, an experienced mason repoints a portion of this early-20th century limestone building. Photo: Robert C. Mack, FAIA.

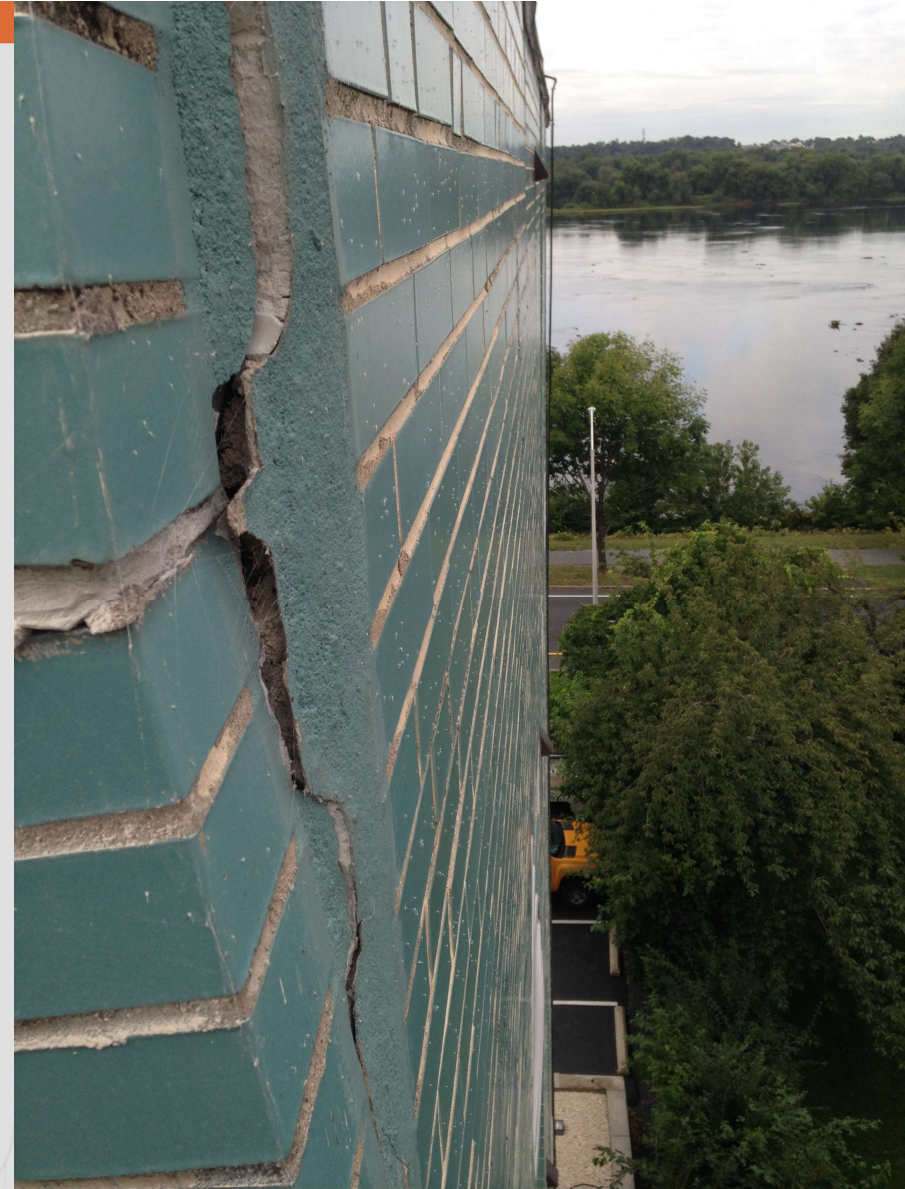
SEPARATION OF MASONRY BRICK TIE FAILURE

Structural Conditions

- Walls out of plane
- Separation of outer wythe of brick
- Failure of corroded steel supports

- Cracking
- Spalling
- Bulging

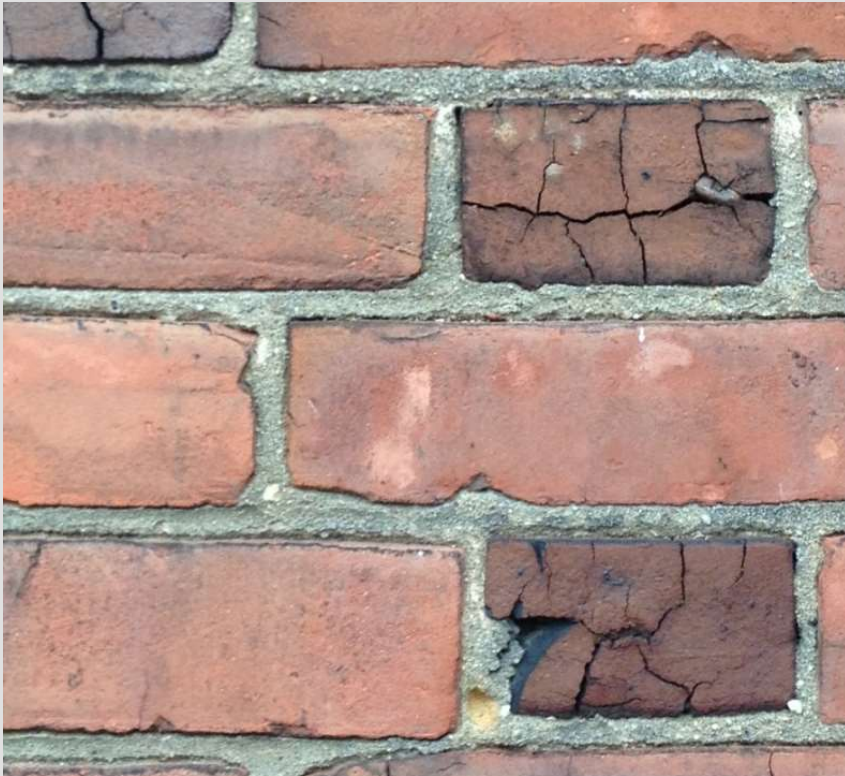
Poor Quality Unit Crack

Low Firing Temperature Exfoliation

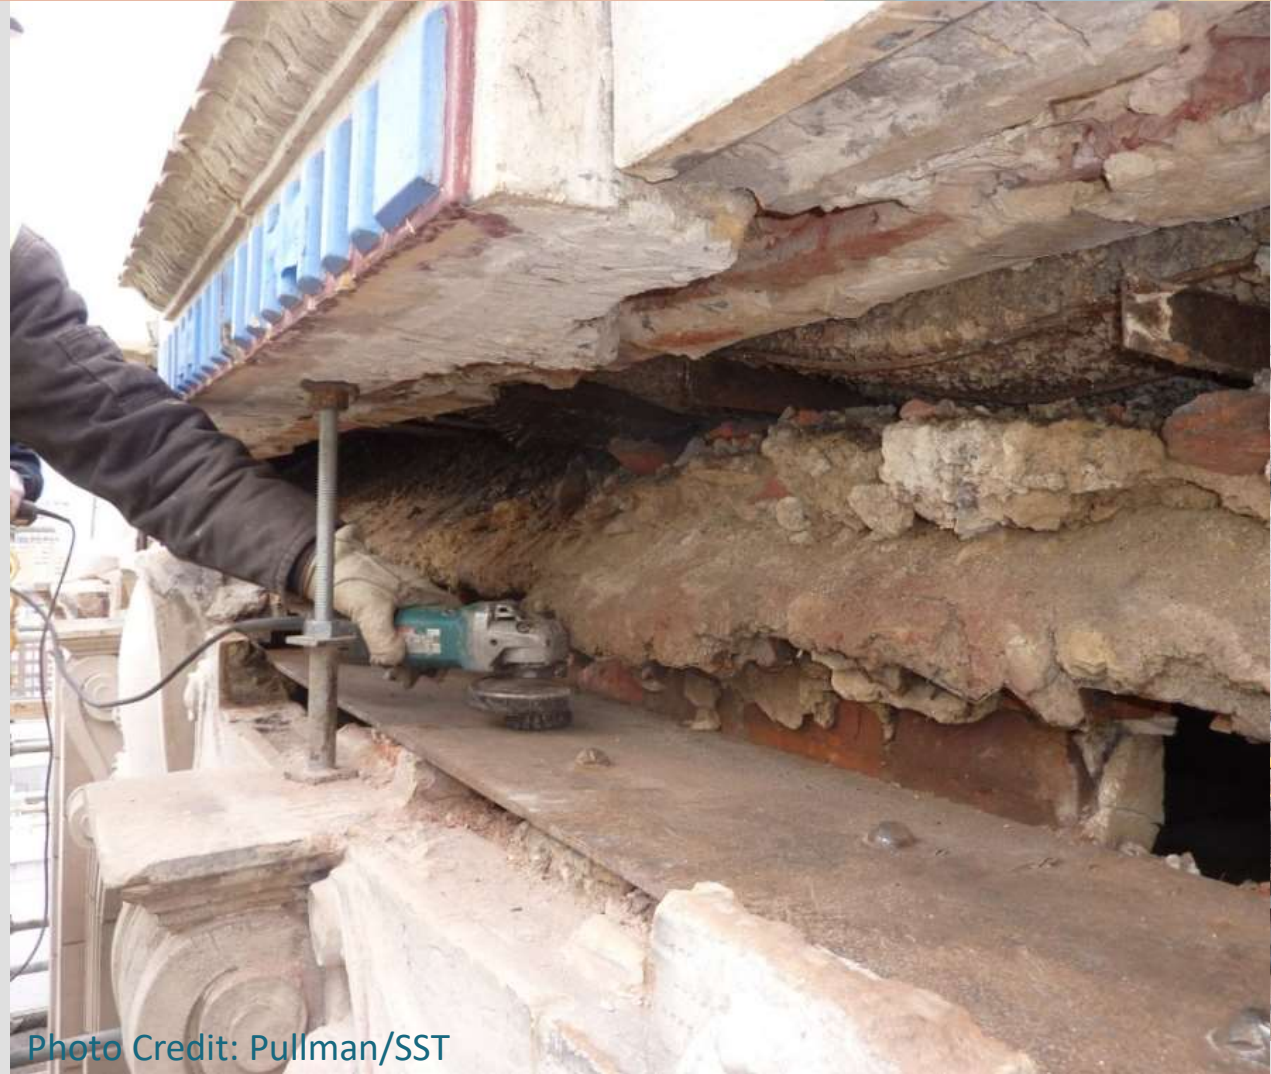
Remove surface corrosion & treat steel with corrosion inhibitor

Retrofit flashing with termination bar, end dams, drip edge and weeps & reinstall original masonry
